Water and Wastewater Policy Group

South Overlea Drive Septic Survey

SURVEY REPORT

April 20, 2017

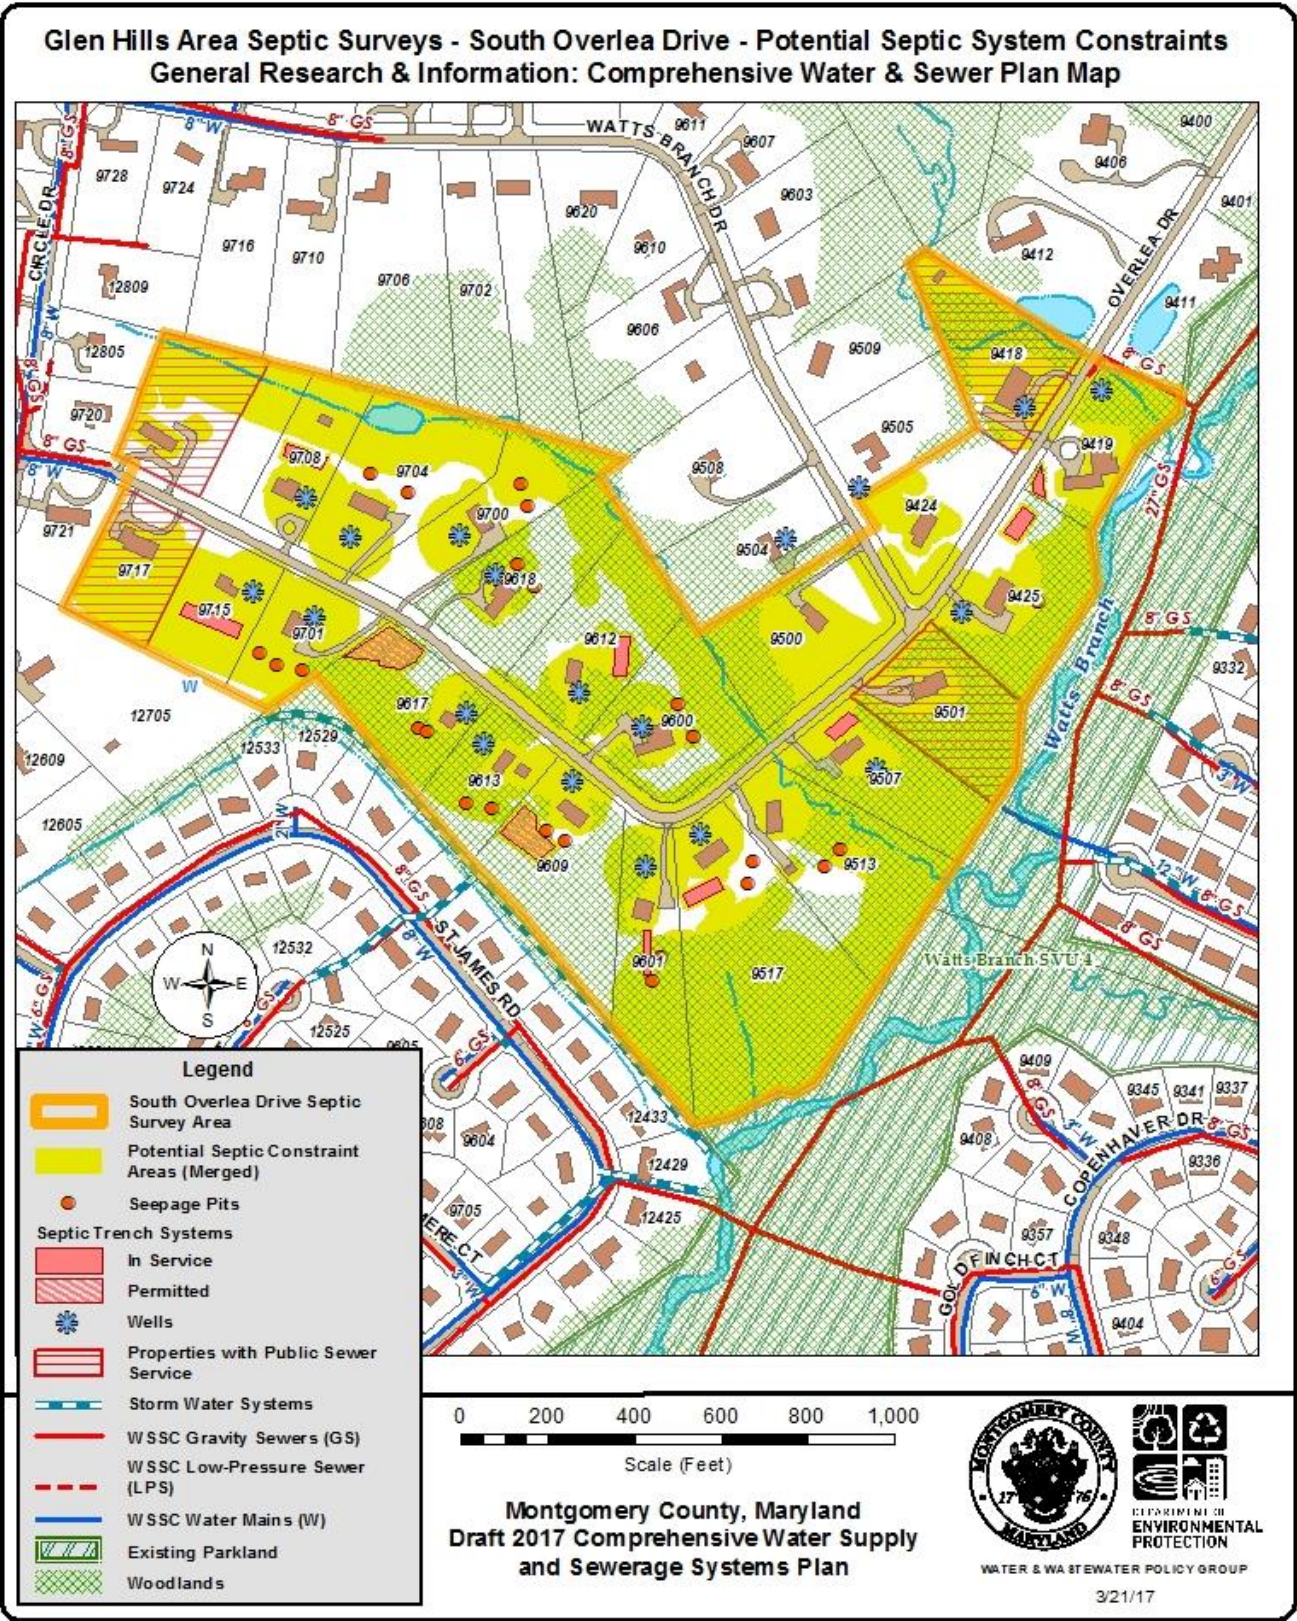
Figure R2: Potential Septic System Constraint Areas

Potential septic system constraints affected every property in the survey area to some degree. DEP considered together the areas potentially constrained for septic system use and the areas of forest cover in the survey area. As shown on the preceding figure (page 6), the majority of lots in the survey area have little or no septic repair or replacement area, particularly in the Potomac Highlands area.
